# Vauxhall CDTI SAAB TID Alfa Romeo MultiJet Inlet Manifold Swirl Flap Rod Repair 1.9 150BHP Diesel Fix Install Fitment Instructions

## **Intro: Vauxhall CDTI SAAB TID Alfa Romeo MultiJet Inlet Manifold Swirl Flap Rod Repair 1.9 150BHP Diesel Fix Install Fitment Instructions**

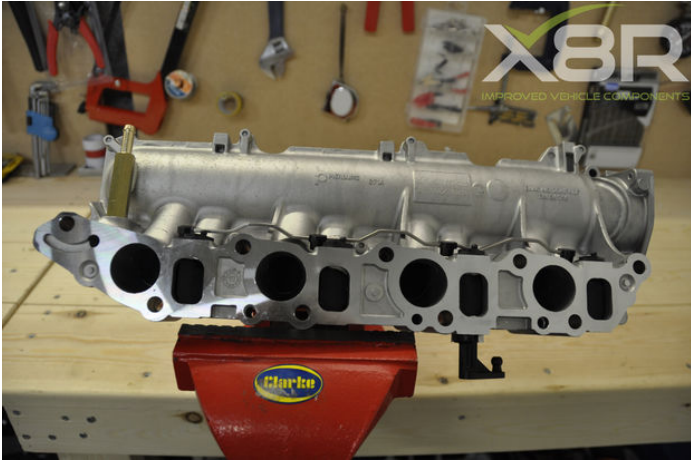
Engine management light (EML) lit, high fuel consumption, rough idling, rough running, poor power and torque, smoking from exhaust, error P2279-11 Intake system air leak, P2075 fault code?

All these symptoms can be caused by the swirl flap operating rod bushes wearing making the operating rod pop off stopping the swirl flaps from operating, you will often see the rod lying on top of the intake manifold.

Rather than replacing the intake manifold at great cost and the problem reoccurring in the future our repair kit solves this issue, replace the unreliable bush bearings with our improved design bearings which will not fail again.

Our bushes are made from billet Brass, fitted with a Viton O-ring and Stainless steel fasteners, designed to never fail again.

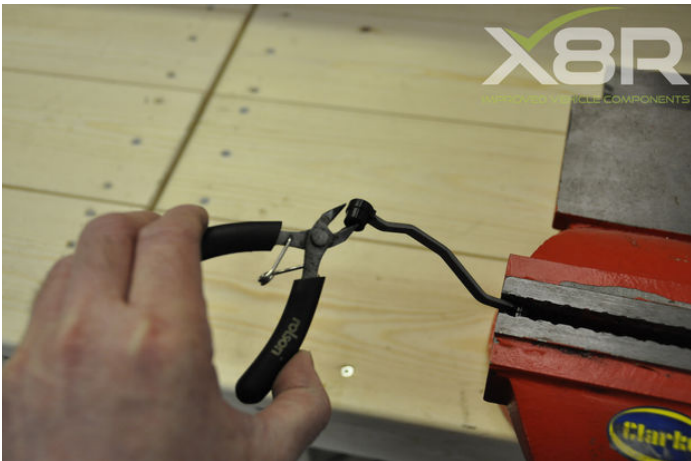
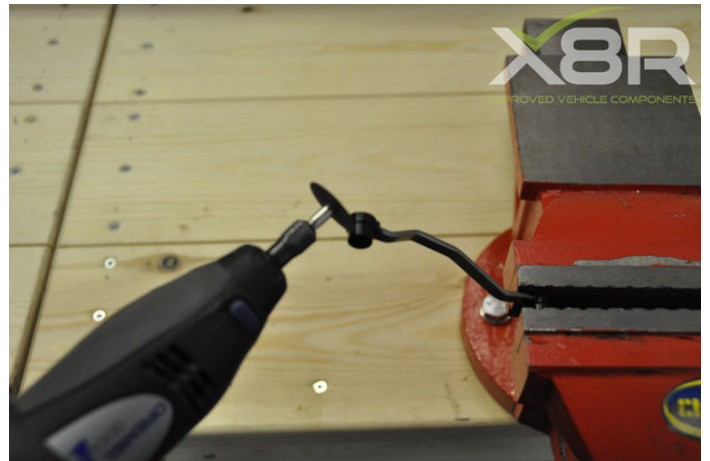
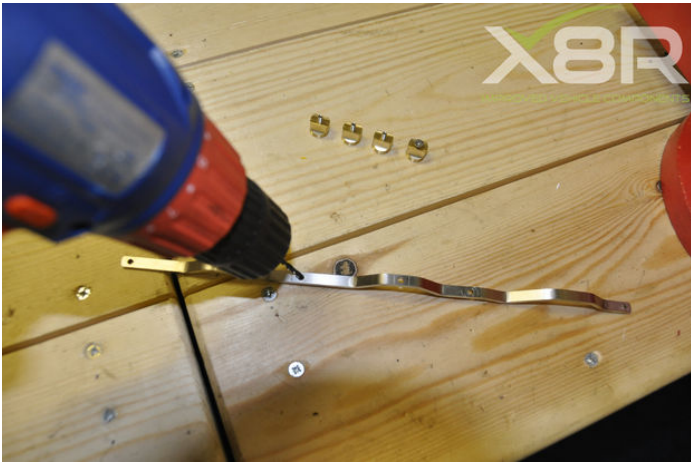
### Step 1: Remove old bushes.

Remove engine cosmetic plastic cover, beneath this you will see the intake manifold. Locate loose operating rod, you will likely find this laying on top of the manifold. If still in position you can bend a coat hanger to make a hook to aid in removing the rod.

Cut away old plastic bushes. This can be done with hand cutters as illustrated or with a power tool such as a Dremel. Take care when removing plastic parts that you do not bend the operating rod. We also recommend eye protection for this step.

Some remnants of the plastic may remain in the holes in the rod, remove these using a drill so that there is a hole where each bush once was.
