BMW Vanos Solenoid N40 N42 N46 N45 O Ring Seals Viton Replacement Repair Instructions.

Intro: BMW Vanos Solenoid N40 N42 N46 N45 O Ring Seals Viton Replacement Repair Instructions.

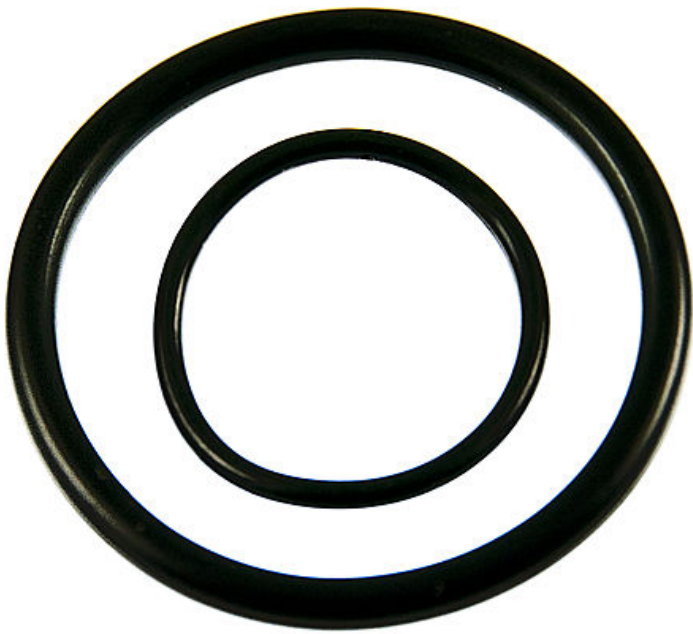
Step 1: Locate and remove solenoids.

Remove cosmetic covers to reveal Vanos unit.

Using a 10mm socket remove the fork brackets, take care to catch the brackets when loosening.

Reinstall solenoids and enjoy leak free use.

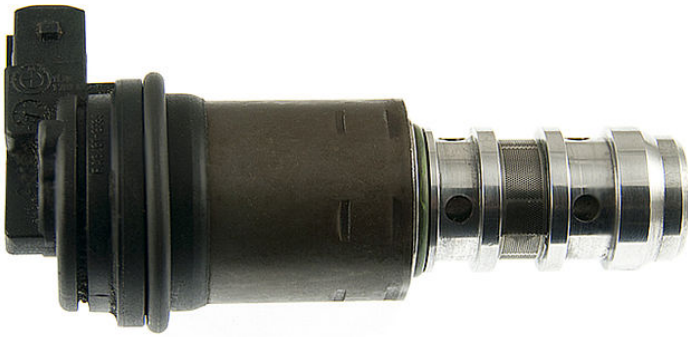
Locate the two solenoids, these are located at the base of the Vanos unit, you will see these next to one another with a fork bracket holding each in place.

Remove the electrical connectors by pushing down on the the metal pin. Take this opportunity to clean the connectors.

You can then wiggle the solenoids out of position, use a cloth to catch any oil.

Clean up solenoids and remove the Green and Black O rings.

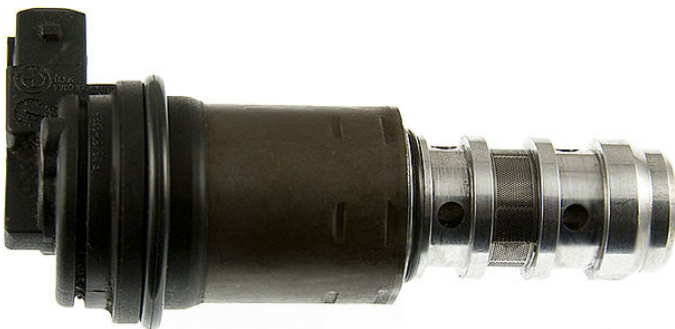
Step 2: Fit new seals.

Fit our new seals to each solenoid.
