## Nissan Qashqai Tailgate Boot Handle Repair Clip Kit Clips 2006 -2013 for Snapped Handle Clips Install Instruction Guide

by x8rltd

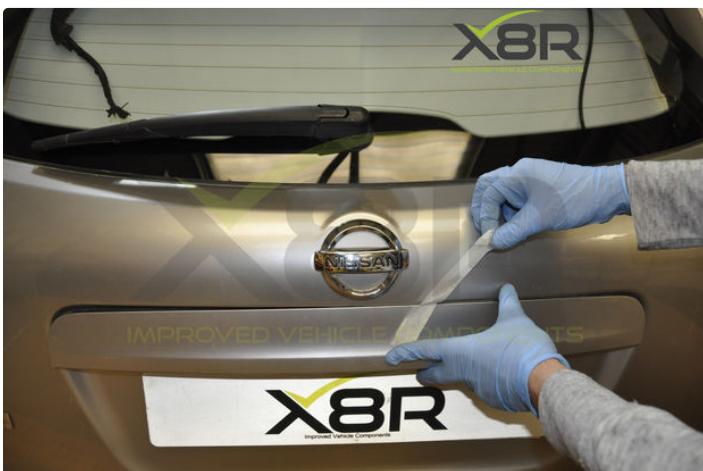
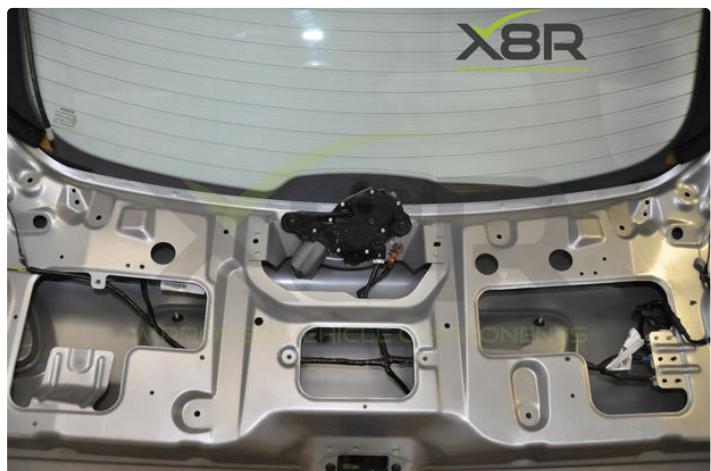
## Step 1: Remove Internal Plastic Trim

Externally hold the handle in place with tape, this makes removing the nuts internally that bit easier.

Remove the internal plastic trim, gently prise around the outside of the plastic to pop out of position.

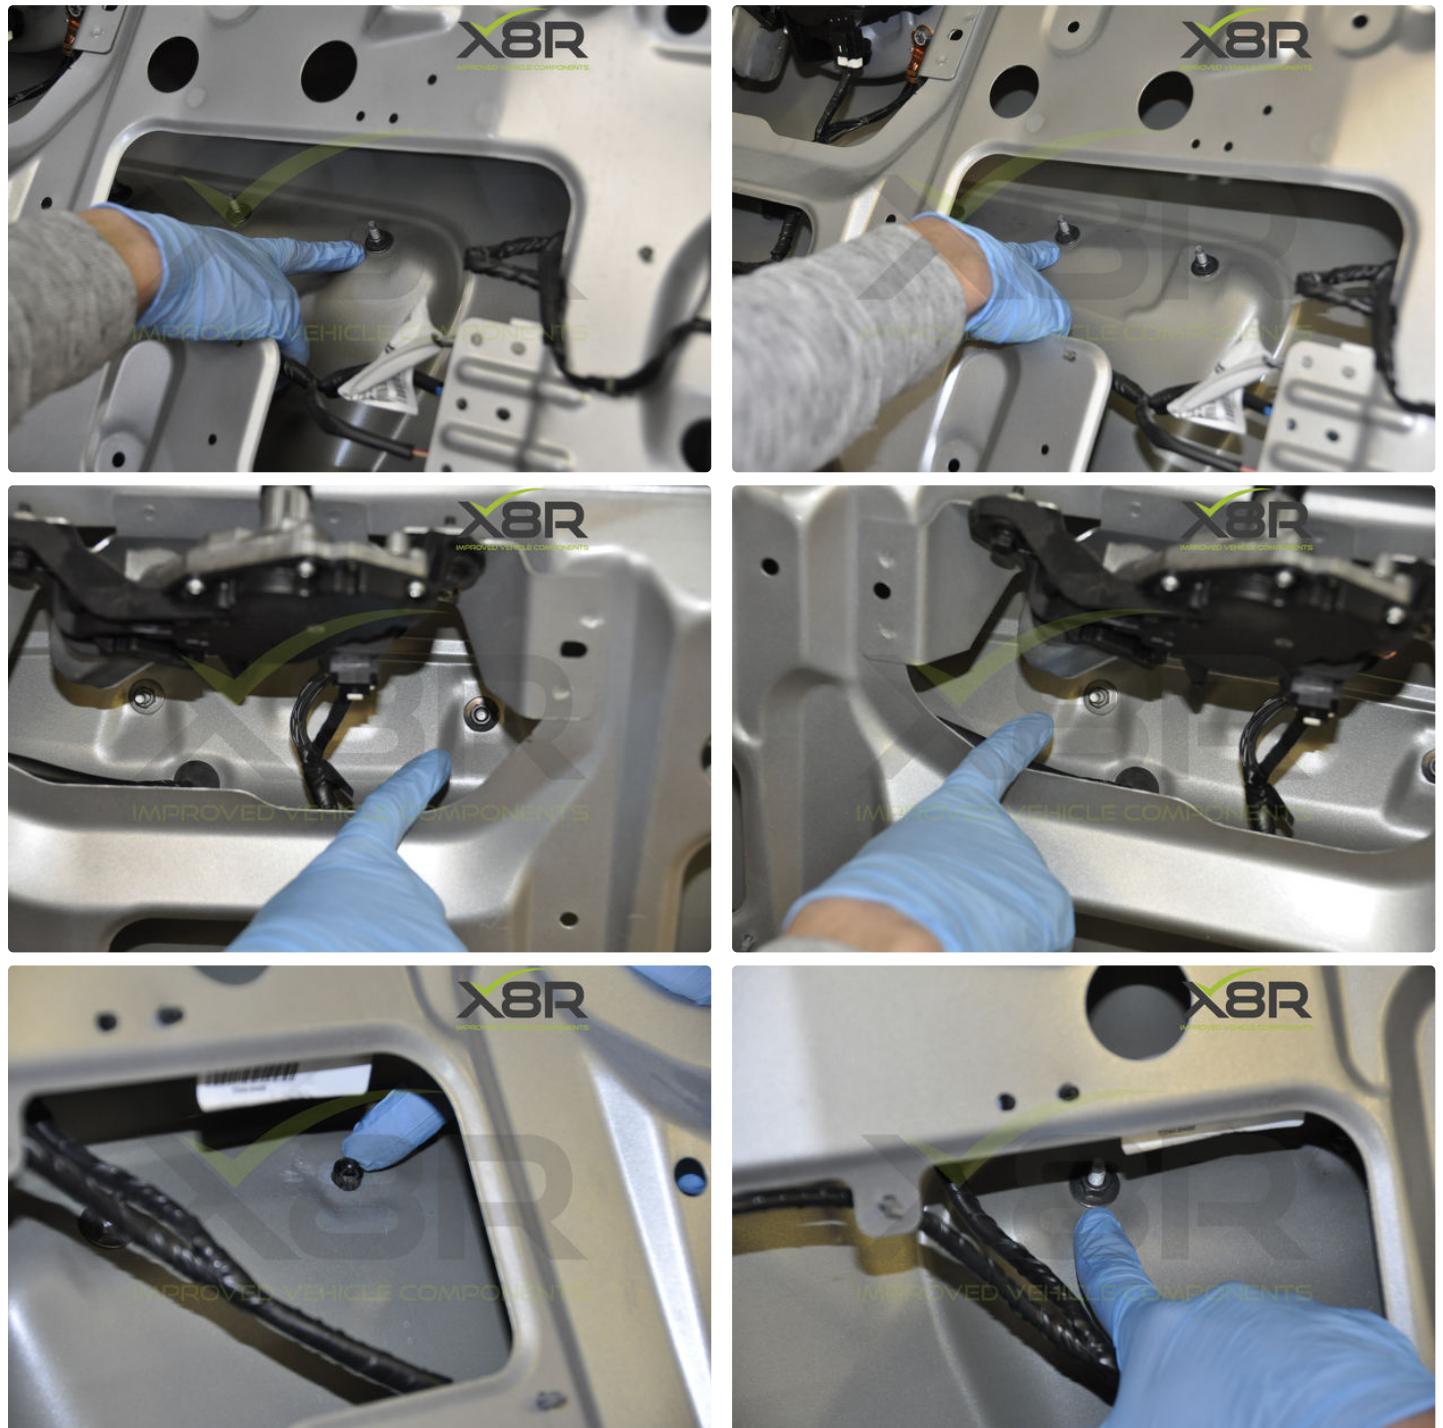
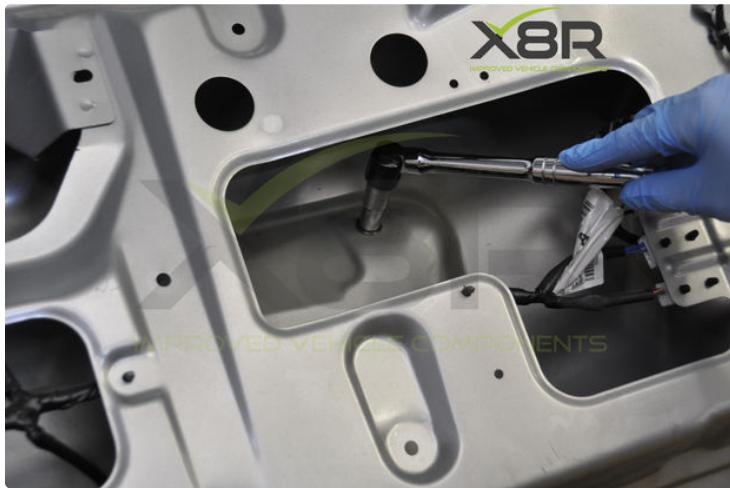
## Step 2: Remove Handle Nuts

Retaining the handle is 5x nuts and 1 black plastic grommet. Look inside the door skin and you will see these nuts.

Two bolts on the Right, two in the center and one on the far Left.

Remove the 5x nuts using a 10mm socket.

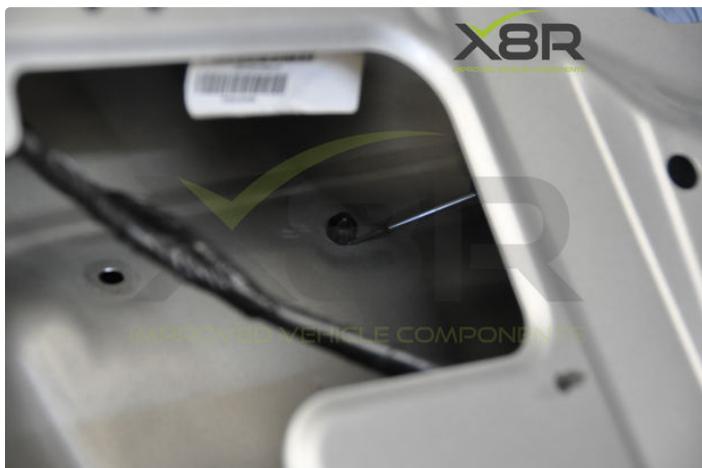
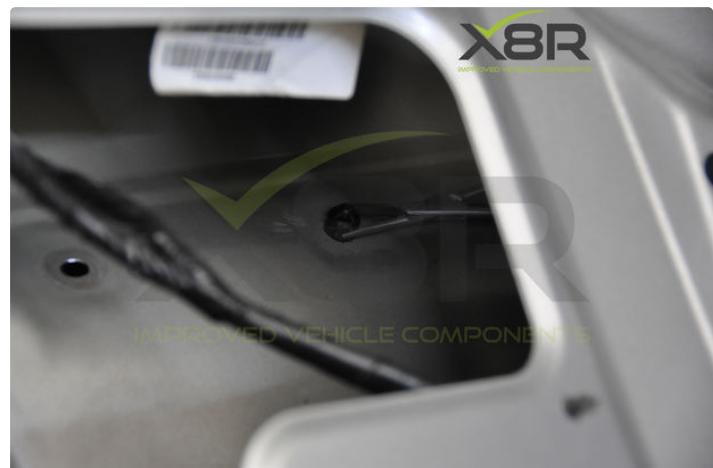
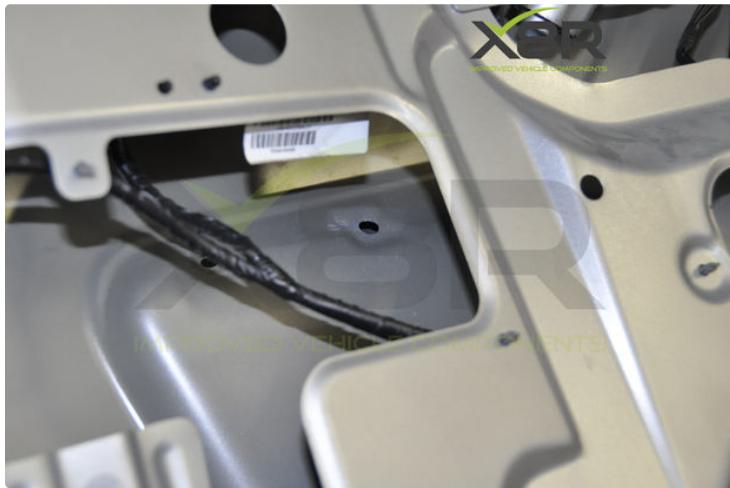
### Step 3: Remove Grommet

The grommet on the Left side of the handle needs pushing through.

There are two small tabs opposite one another, the tabs need to be compressed either with forceps, long nose pliers, or a small flat bladed screw driver then the grommet can be pushed out.

At this point you may need to loosen the tape on the outside of the vehicle to push through the grommet and remove the handle.

When removing the handle there will be loose screws and possibly the grommet as the clips have snapped, take care to retain all 5 screws and the grommet.

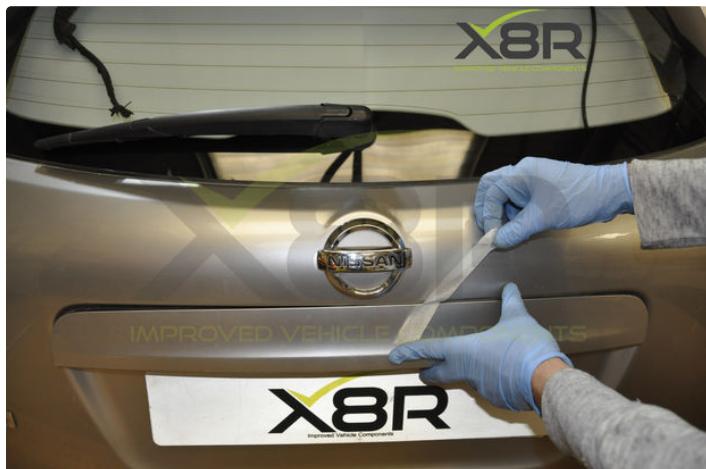
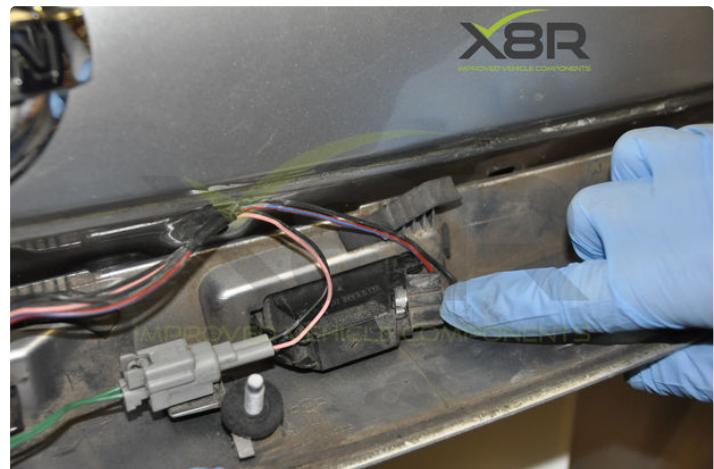
## Step 4: Remove Handle

To remove the handle you will need to disconnect the electrics.

The 2 x number plate bulbs should be removed, simply rotate these to the left and pull to remove.

The connector to the tailgate button needs removing. Slide this off of its fixing on the handle. Pry the connector gently apart using a flat bladed screwdriver.

Remove handle.

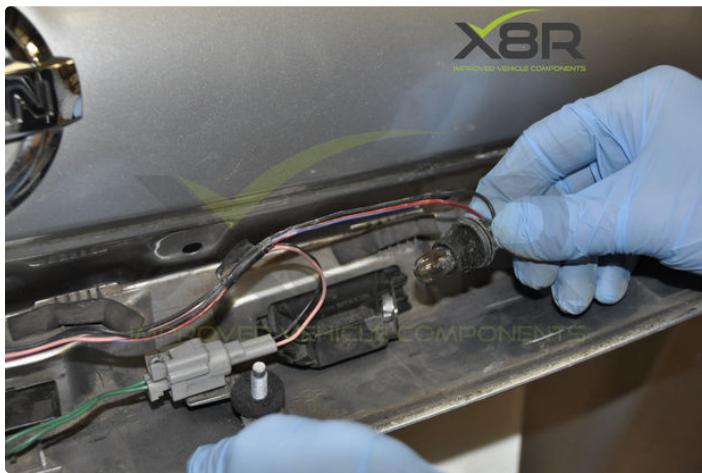
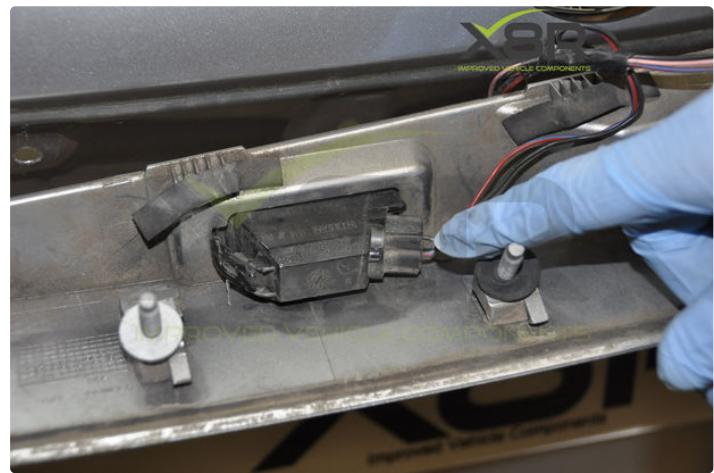
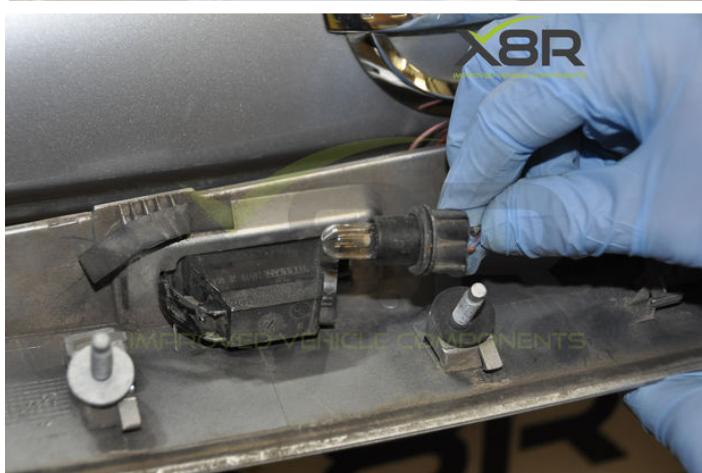
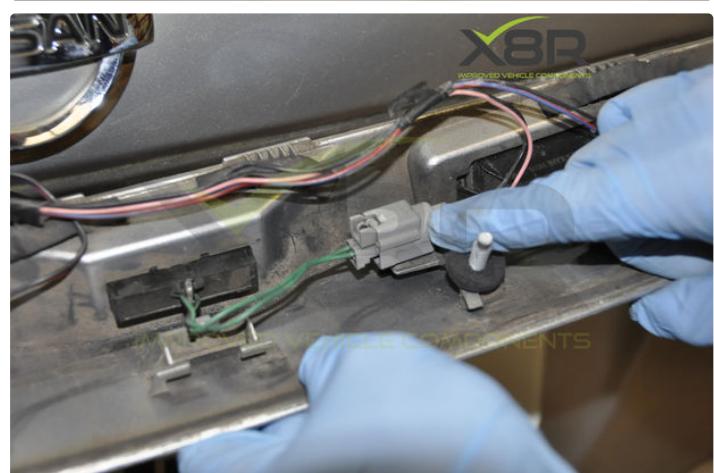
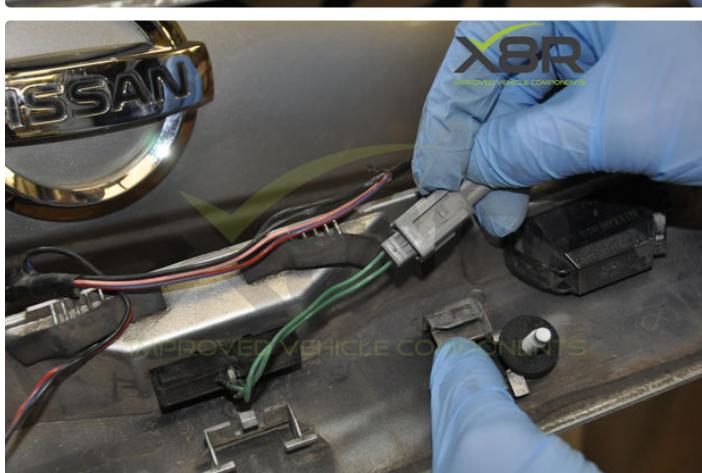
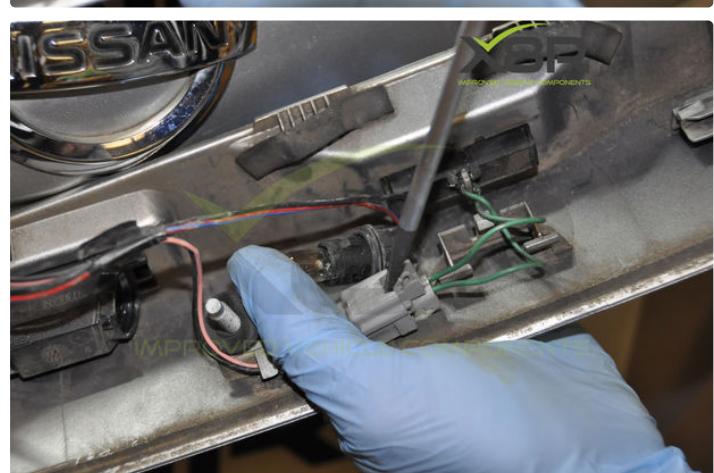
## Step 5: Remove Screws

Remove all 5 screws and grommet, some may still be retained by the clips, these will simply slide out of position.

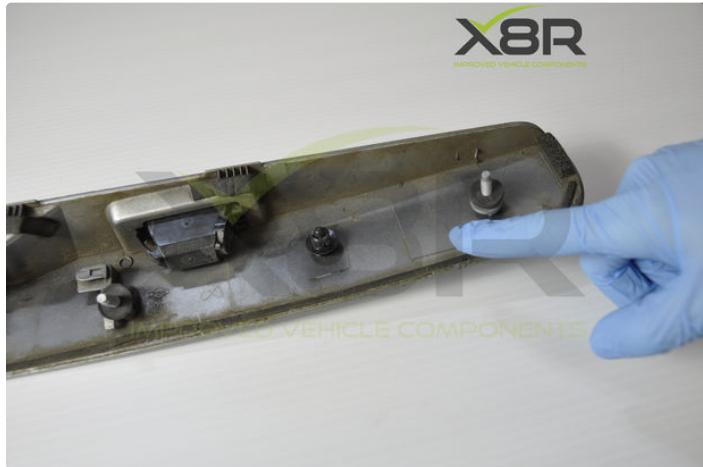
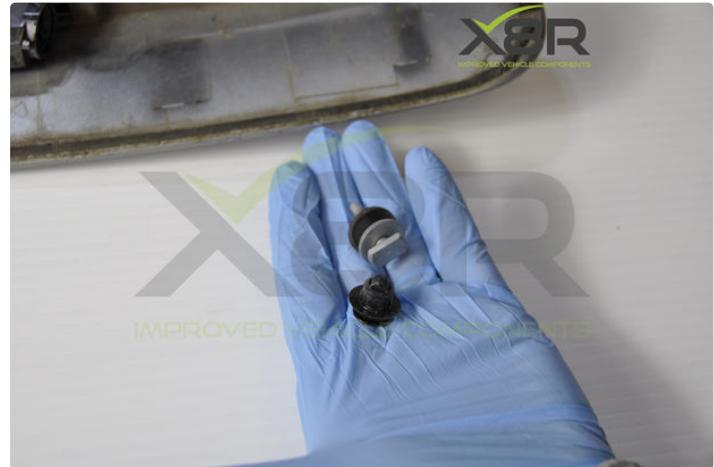
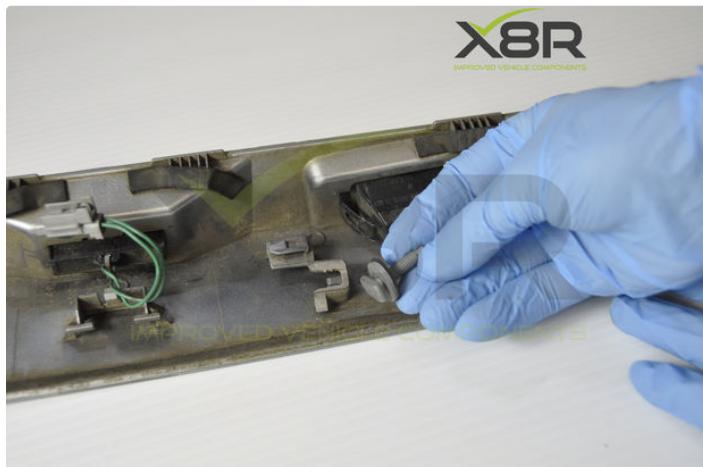
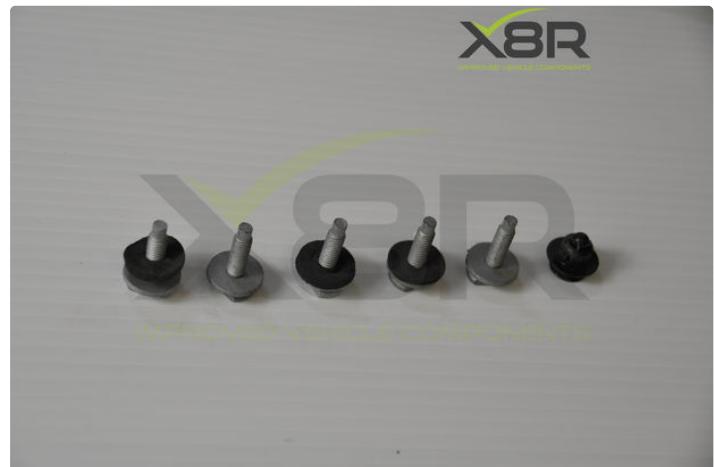
## Step 6: Remove Clips

You will see once the handle is removed where the clips have snapped.

Remove completely the two clips on the Left side of the handle and the two on the Right side. The center clips if still usable can remain.

Snap these off with pliers, or cut away with a cutting tool.

You will need to remove all remnants of the clips so the surface is flat ready to accommodate our new clips.

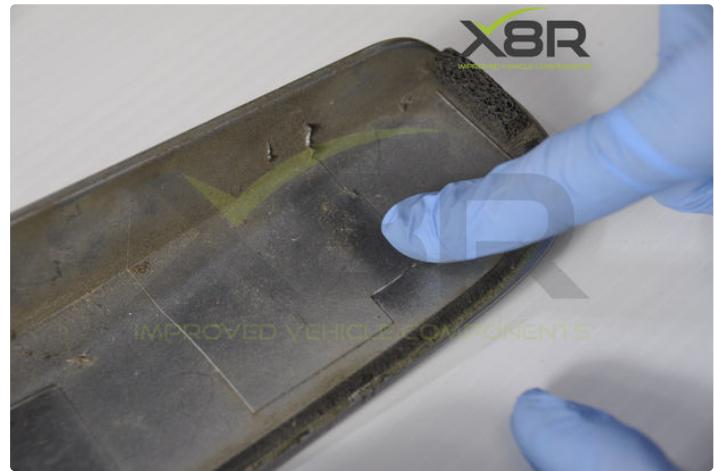
## Step 7: Align Our New Clips

Align our new clips in position as shown, our clips have a cut out so they can be positioned correctly. Ensure the bottom section of our clip block is flat to the bottom of the handle.

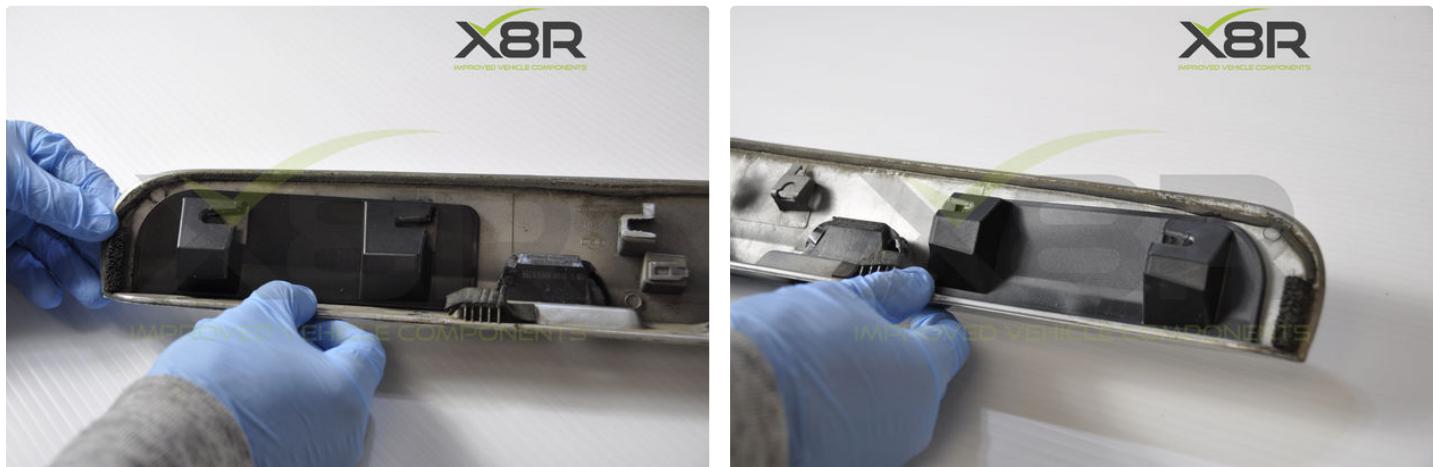
## Step 8: Apply the Acetone

Using the correct PPE; pour the Acetone in to a container and dip in a paint brush.

Apply the Acetone to the area where the clip block will be fitted and to the reverse of the clip block. Put pressure on this with the brush and the ABS plastic of

the clip block and the handle will start to melt allowing the two parts to be fused together.

Take care at this stage not to splash Acetone on the front of the handle as this will damage the paint work.

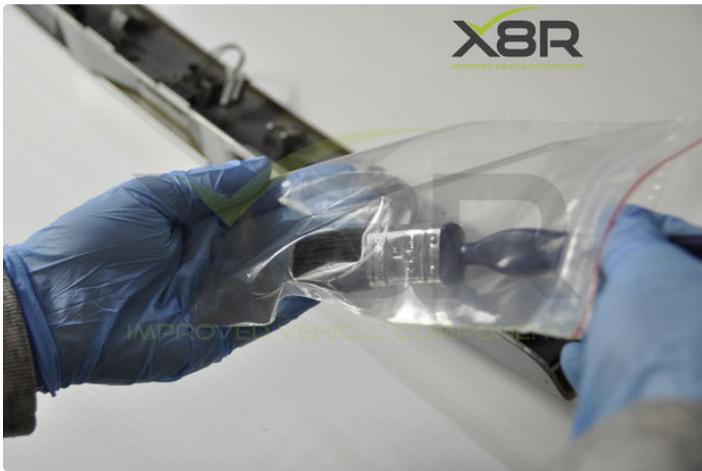
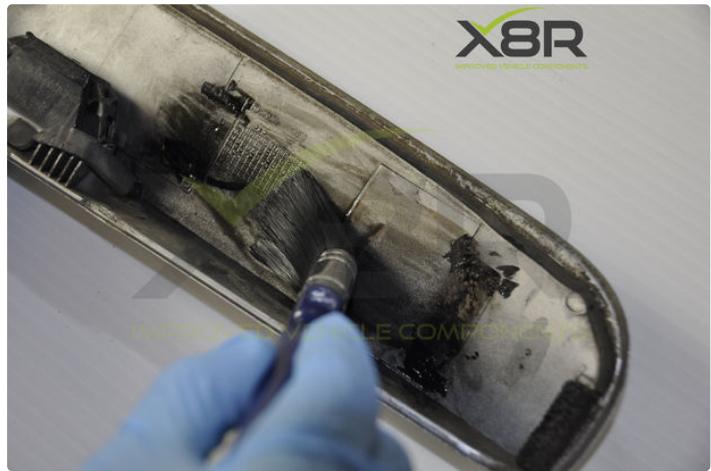
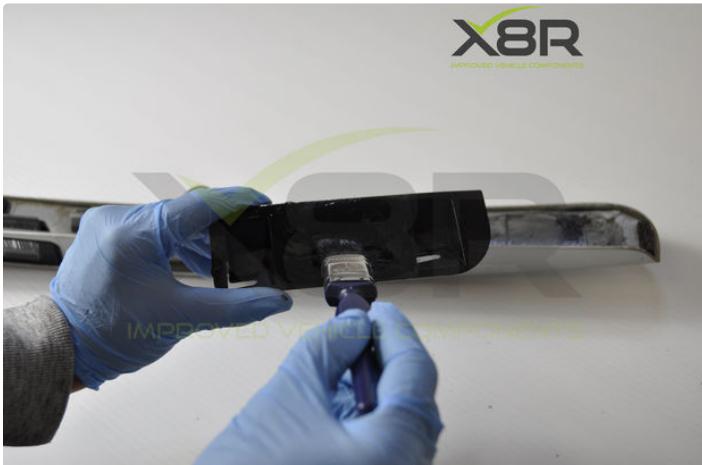
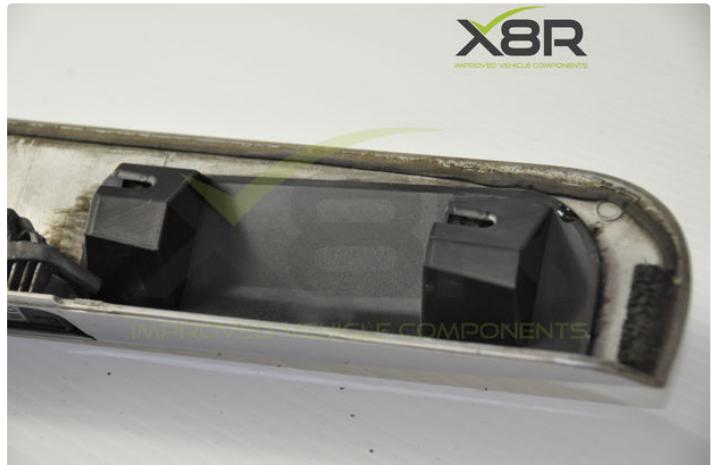
## Step 9: Clamp in Position

Clamp the clip block in position whilst the plastic sets.

Once clamped apply a little more Acetone around the edges of the clip block to ensure good fusion at the edges.

The plastic typically takes a few hours to cure.

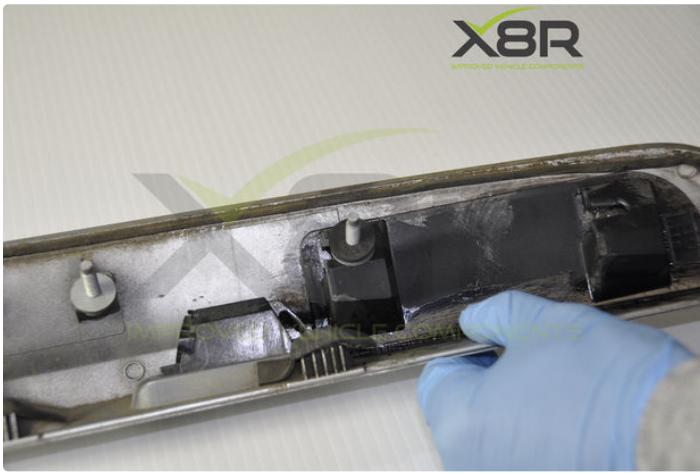
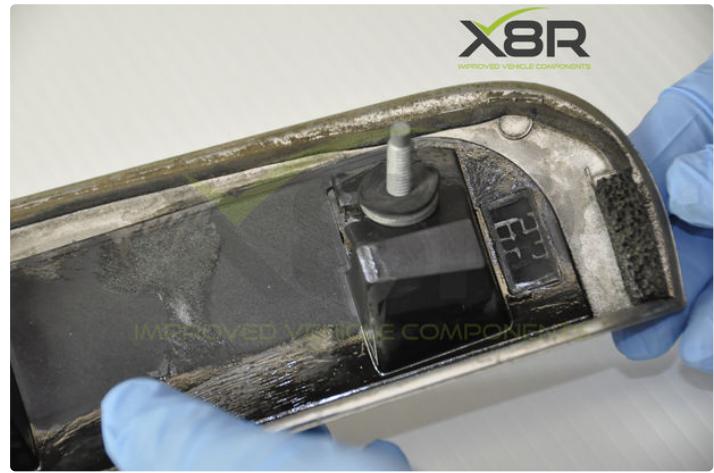
## Step 12: Refit Electrics

Reconnect the connector for the boot button, the two halves simply push together.

Slide this connector back on to its retainer on the handle.

Refit the x2 number plate bulbs, these insert and rotate Clockwise to secure.

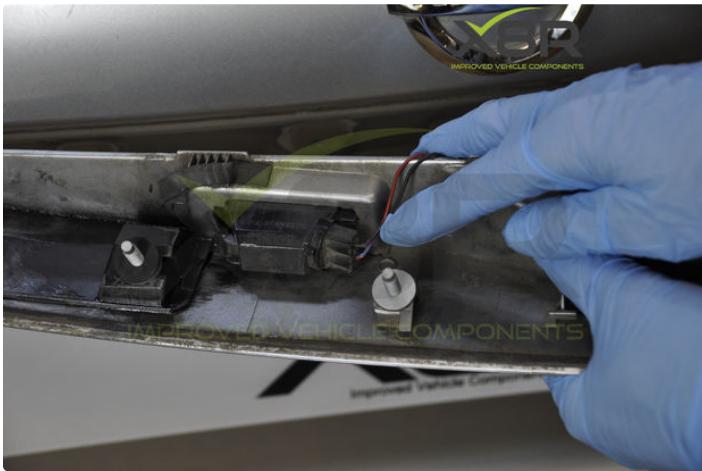
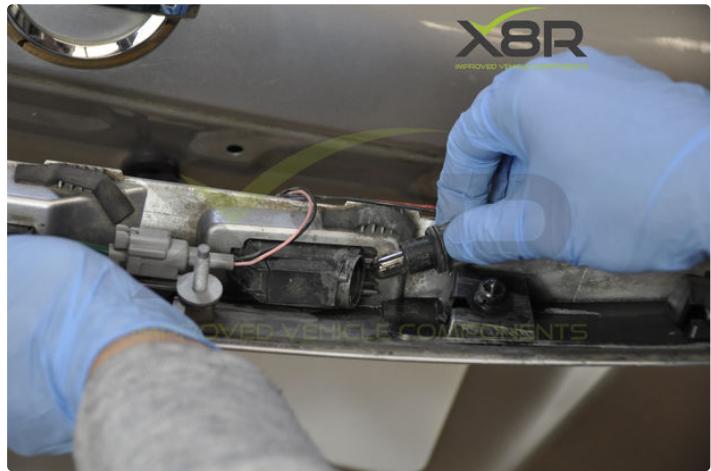
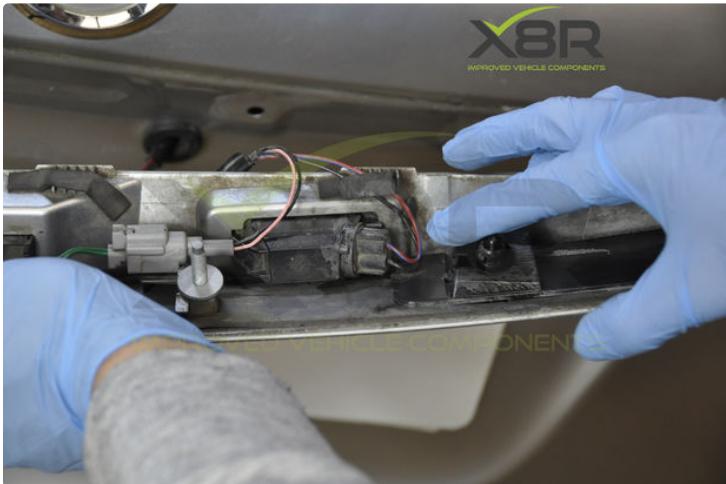
### Step 13: Refit Handle

Refit the handle, align the screws with the holes in the tailgate metal and push in, take care to not trap any wires.

Some force will be required on the Left side to engage the grommet.

Once in place tape in position, this will make refitting the nuts internally easier.

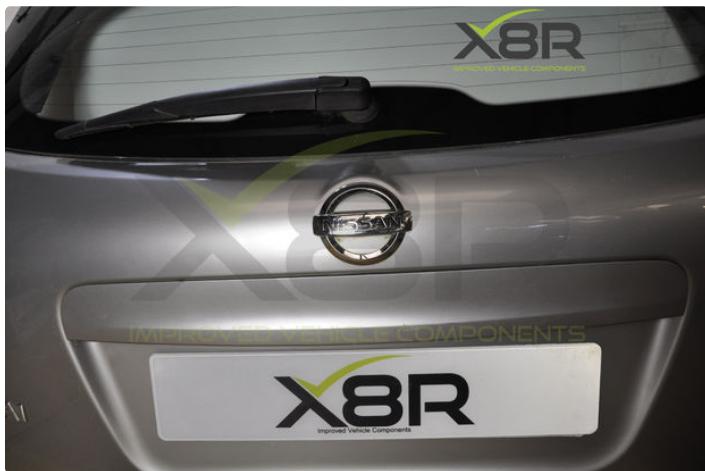
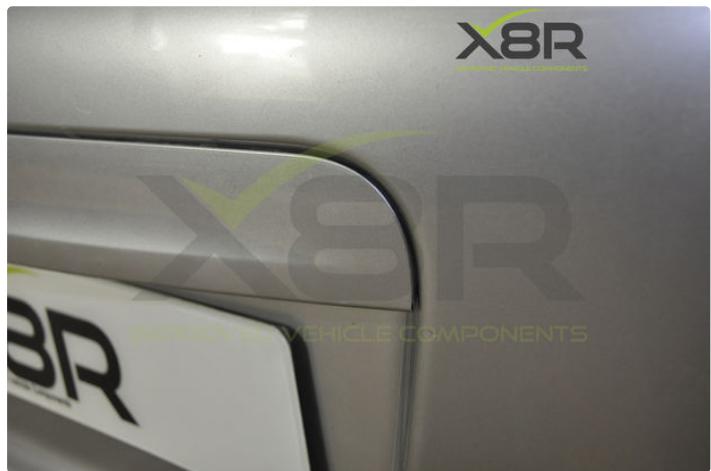
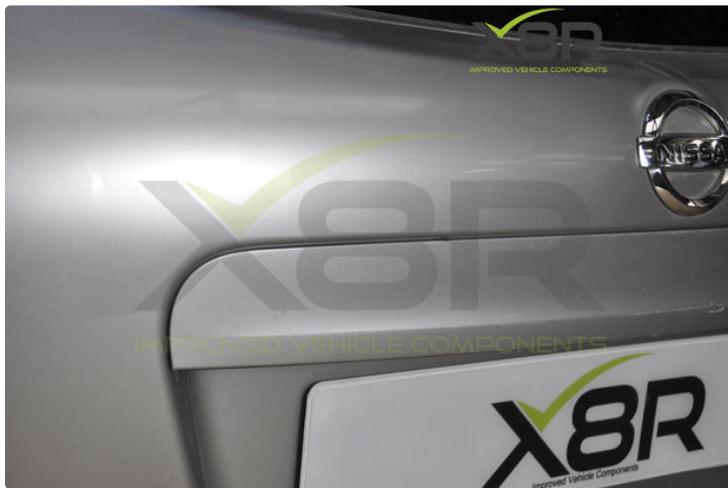
## Step 15: Handle Reinstalled.

This completes the repair. If you need any further guidance on this install or would like to purchase the parts shown please call us on +44 01843 446643 or email us at [sales@x8r.co.uk](mailto:sales@x8r.co.uk).
