# Vauxhall CDTI SAAB TID Alfa Romeo MultiJet Inlet Manifold Swirl Flap Bush Repair Instructions

## Introduction

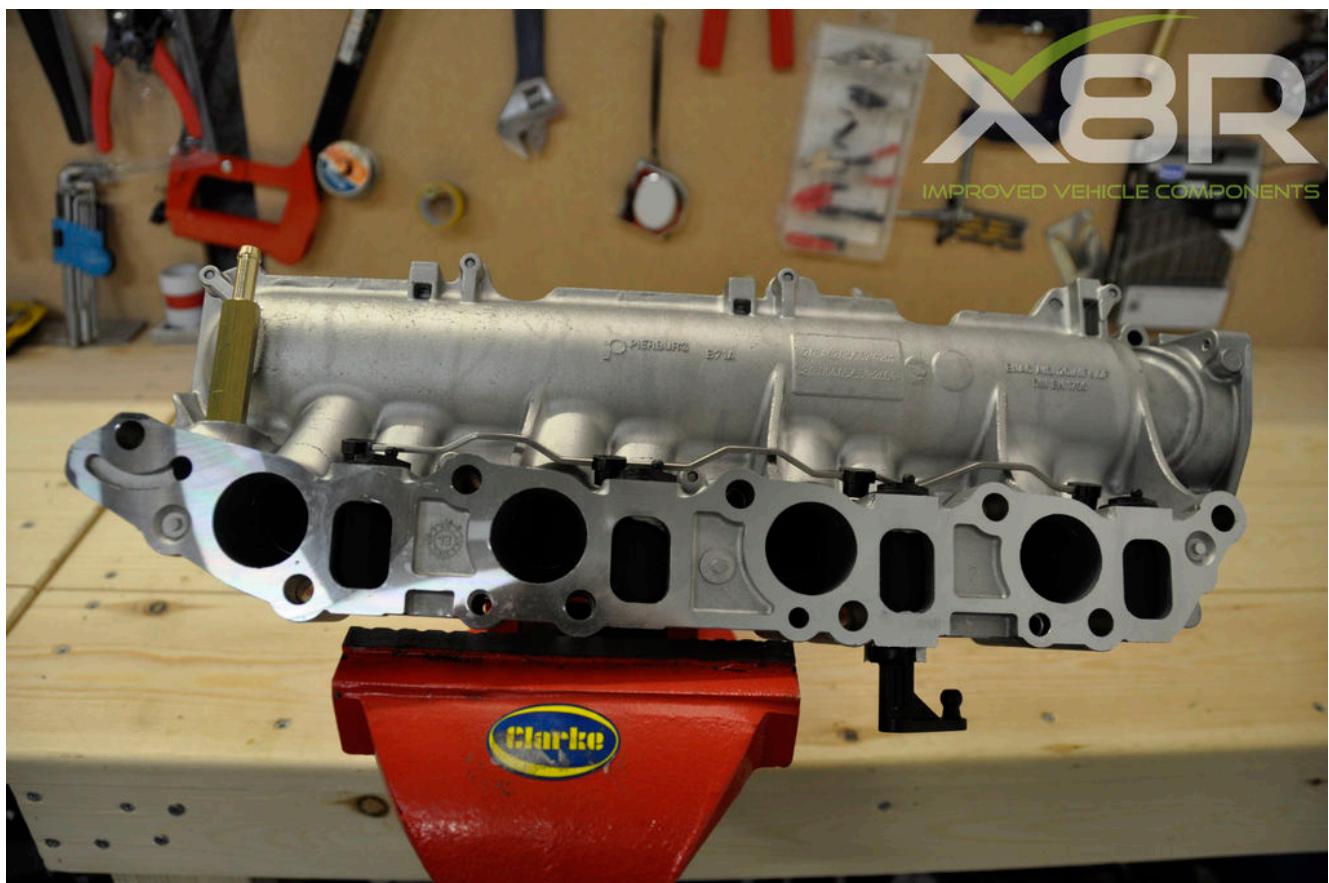
All these symptoms can be caused by the swirl flap operating rod bushes wearing making the operating rod pop off stopping the swirl flaps from operating, you will often see the rod lying on top of the intake manifold.

Our bushes are made from billet Brass, fitted with a Viton O-ring and Stainless steel fasteners, designed to never fail again.

reoccurring in the future our repair kit solves this issue, replace the unreliable bush bearings with our improved design bearings which will not fail again.

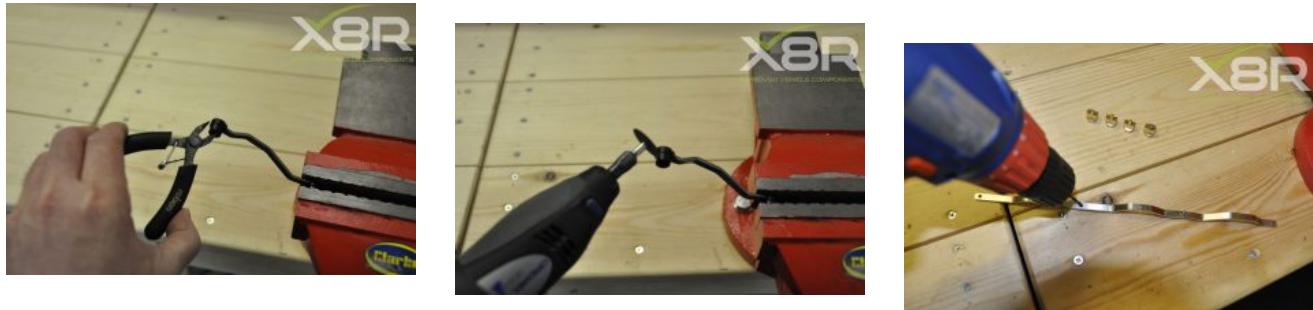
## Step 1: Remove old bushes

Remove engine cosmetic plastic cover, beneath this you will see the intake manifold. Locate loose operating rod, you will likely find this laying on top of the manifold. If still in position you can bend a coat hanger to make a hook to aid in removing the rod.

Cut away old plastic bushes. This can be done with hand cutters as illustrated or with a power tool such as a Dremel. Take care when removing plastic parts that you do not bend the operating rod. We also recommend eye protection for this step.

Some remnants of the plastic may remain in the holes in the rod, remove these using a drill so that there is a hole where each bush once was.

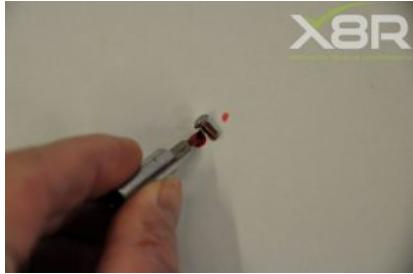
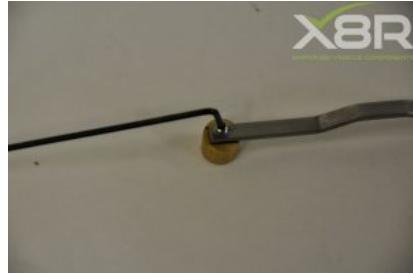
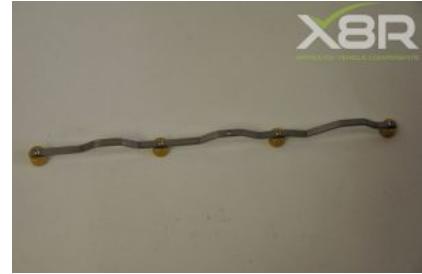
## Step 2: Attach bushes to rod

Add thread-lock to the screw threads and attach the bushes to the rod as shown.

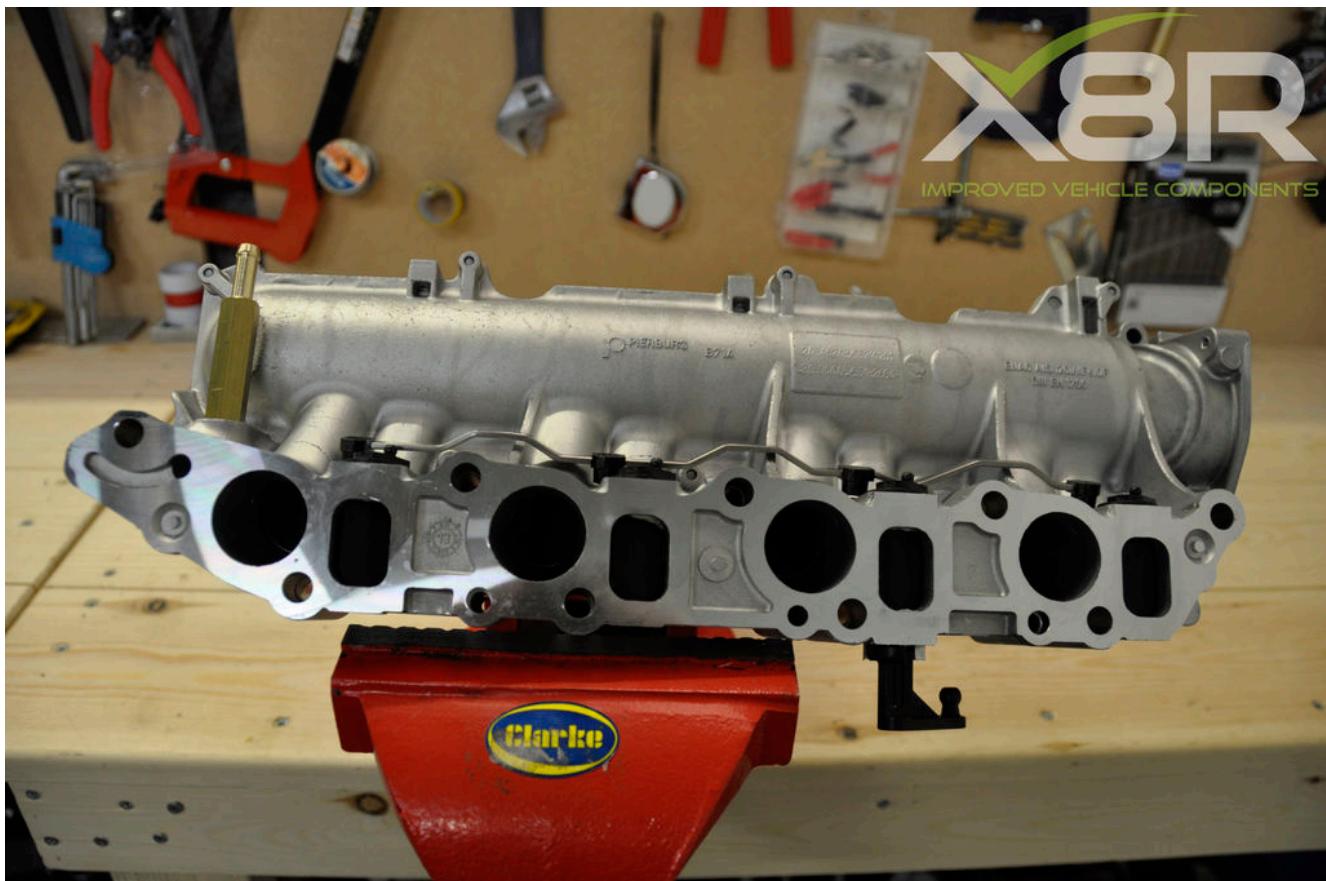
## Step 3: Refit operating rod

Refit operating rod. Push down on rod to secure using long reach pliers or reshape coat hanger hook to push down on rod.
