Audi SEAT Skoda VW VAG 2.0 TDI Intake Inlet Manifold Flap Actuator Motor Repair Bracket P2015 Error Fix Kit Install Instruction Guide

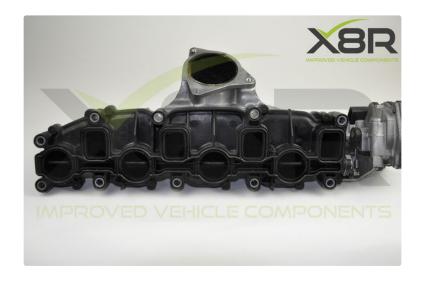
Our bracket is unique in design, CNC machined from billet aluminium polished then anodised Our bracket utilises stainless steel fasteners providing the best solution to this common fault.

We also include a replacement spring for the actuator motor as this can often be lost or damage when fitting the bracket. Fit our bracket quickly and simply and cure this common fault.

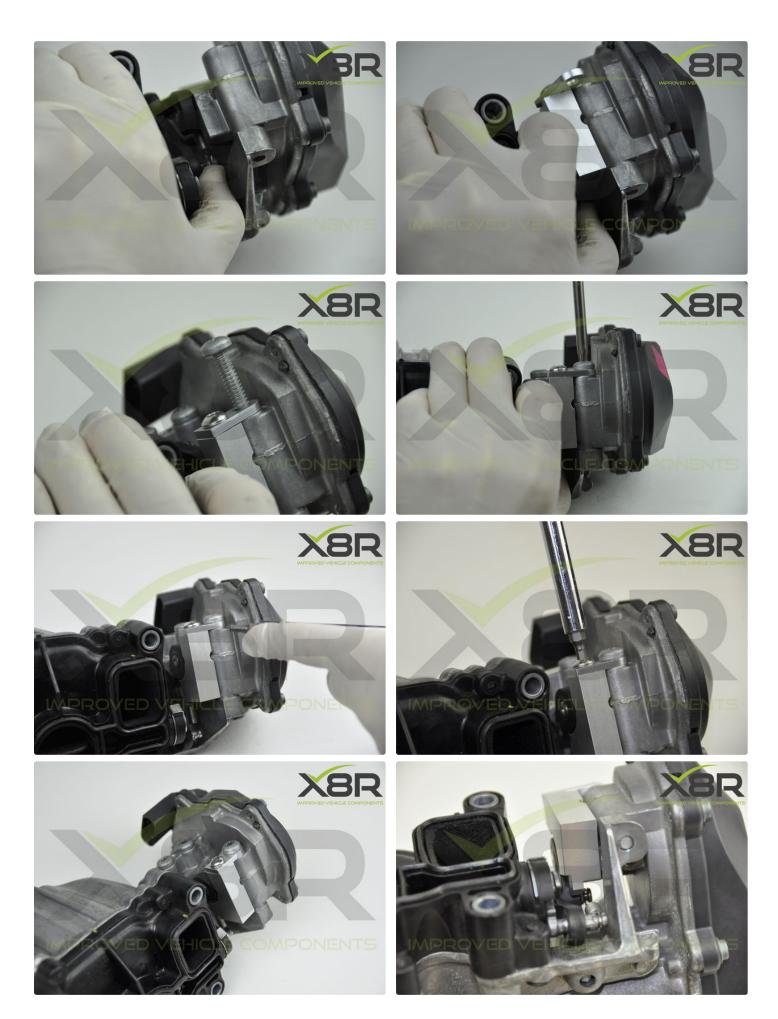
Step 1: Fitting Our Bracket on Aluminium Manifolds

Locate the cast nub just below the actuator ball joint as shown in the first image.

Using a T30 Torx screw driver remove the screw shown which joins the actuator motor to the manifold.

Orientate our bracket as shown, loosely tighten the Allen key head screw so that the top section of the bracket sits square to the lower section of the bracket.

Push forwards on the actuator arm and locate our

bracket on the cast nub.

Keeping the bracket square refit the screw through the bracket top section that joints the actuator motor to the manifold.

Again keeping the bracket square tighten the Allen key headed screw on the bracket.

This completes the fitting, you can test the limit of the bracket by pushing on the actuator arm.

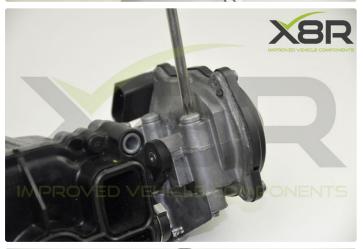
Step 2: Fitting Our Manifold Bracket in Situ

It is often possible to fit our bracket without removing the manifold from the vehicle. To do this the actuator is removed and the bracket fitted.

Remove the spring fitted between the actuator ball joint and manifold ball joint. Using a pair of pliers or forceps grip the spring and pull loose.

Remove the 3 screws joining the actuator motor to the manifold.

The actuator motor can now be separated from the manifold. The ball joint linkage will remain connected, tilt the actuator motor forwards to release the linkage.

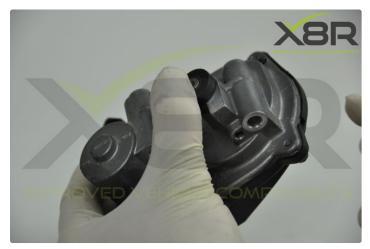
Step 3: Fit Our Bracket to the Motor

Push forwards on the motor ball joint and push our bracket on to the cast nub.

Loosely tighten the Allen key head screw keeping the two sections of the bracket square. Fit the motor to manifold screw through the bracket and motor as shown, this will loosely retain the bracket.

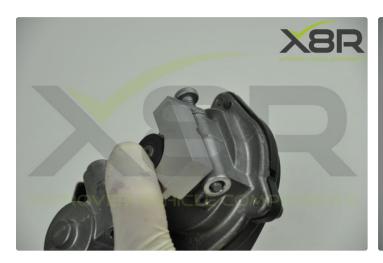
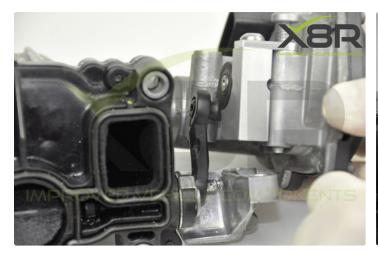
Step 4: Refit the Actuator Motor to the Manifold

Push the ball joint from the motor back in to the operating arm from the manifold.

Ensuring the bracket remains square tighten the screw to the manifold that was inserted through the bracket and refit the two other screws joining the motor to the manifold. Tighten the Allen head screw on the bracket ensuring the bracket remains square.

Fit our replacement spring between the motor ball joint and manifold ball joint.

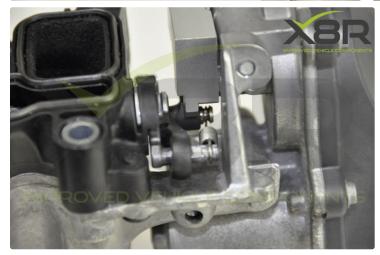
Step 5: Fitting Our Bracket to the Plastic Manifold

Locate the cast nub just below the actuator ball joint as shown in the first image.

Orientate our bracket as shown, loosely tighten the Allen key head screw so that the top section of the bracket sits square to the lower part of the bracket. Push forwards on the actuator arm and locate our bracket on the cast nub. Keeping the bracket square refit the screw through the bracket top section that joints the actuator motor to the manifold. Again keeping the bracket square tighten the Allen key headed screw on the bracket.

This completes the fitting, you can test the limit of the
