Saab 9-3 Sport Stiff Gears Repair-Gear Turret Repair Instruction Guide. 55556311

Introduction

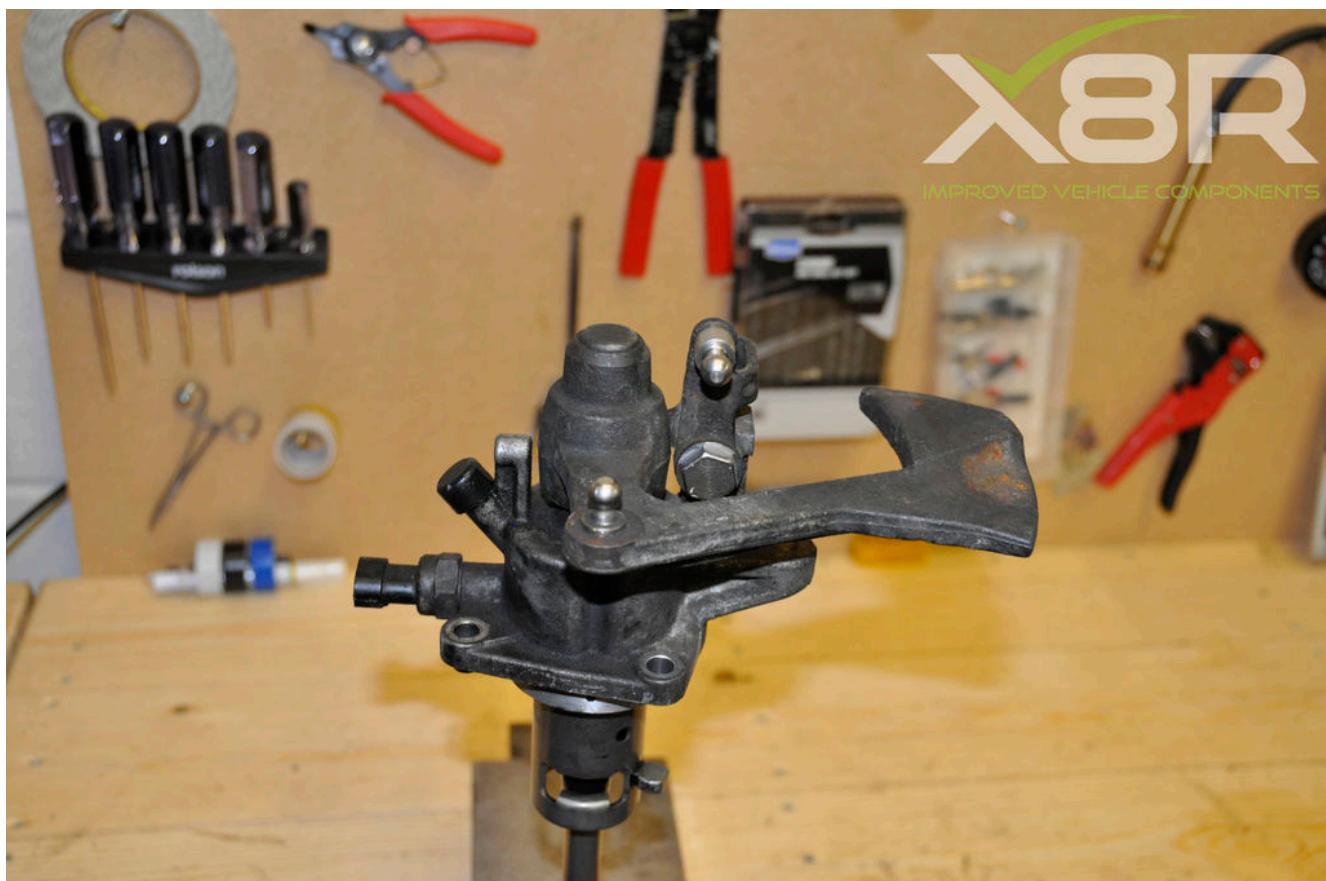
Is your gear stick seized in position, or maybe it won't return to neutral? Stiff to change gear? Difficult to find gears? Gear change vague and unable to select correct gear? The likely cause of the faults noted above and most common cause is a worn pivot on the gear turret. On the gear turret is a pivot point, a pivot pin operates through a nylon sleeve, this is a poor design and the nylon breaks down over time causing the symptoms noted above. A small amount of play in this pivot translates to problems selecting gears.

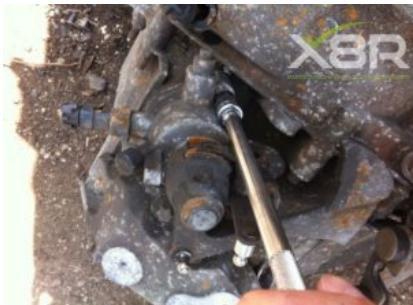
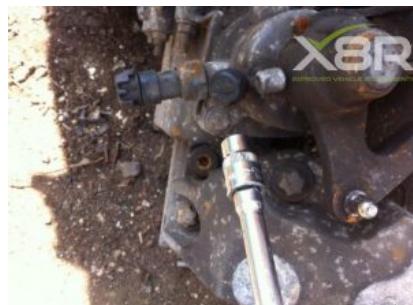
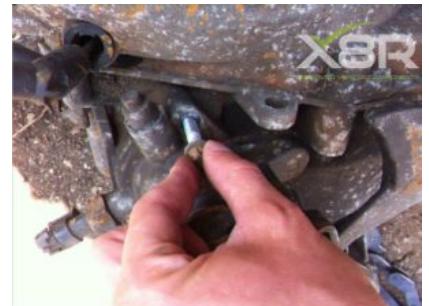
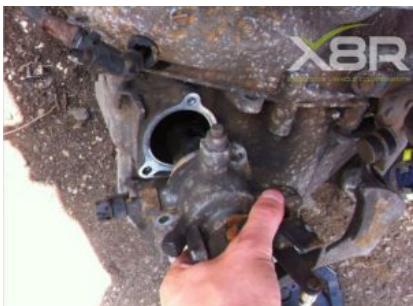
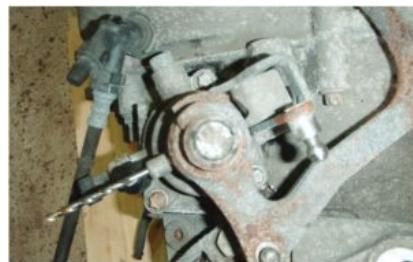
Step 1: Remove turret

Put vehicle in to neutral.

Disconnect hose from left side of battery box.

Quarter turn the two nylon screws on the cover, tilt backwards and remove cover.

Disconnect negative then positive terminal, remove bolt that locks the battery in place.

Remove battery.

Remove battery box.

Remove electrical connectors to turret.

Lock the turret with 4mm drill bit.

Remove the 3 screws on the turret.

Lift turret out of position.

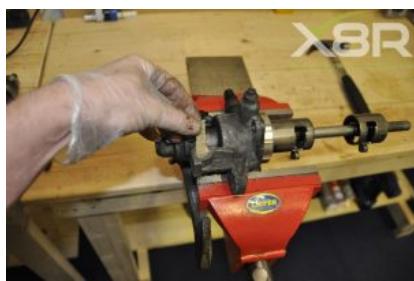
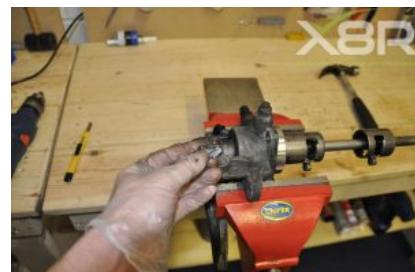
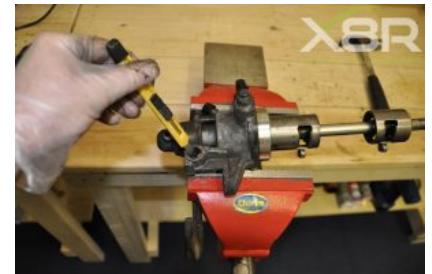
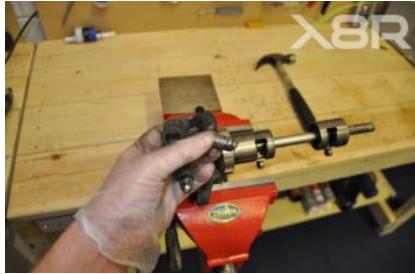
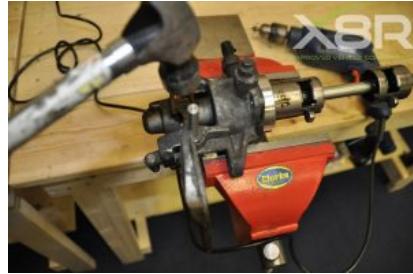
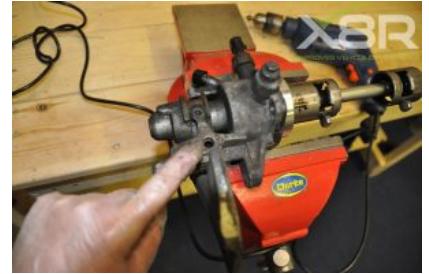
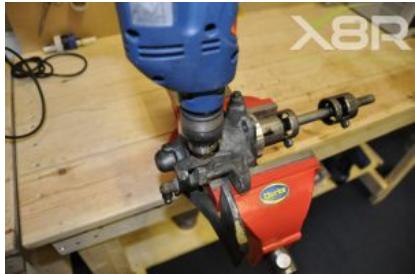
Step 2: Remove worn pivot pin

Drill out pivot pin using drill bit included, do this on a low speed until enough metal is removed to allow pivot to be removed.

Push pivot out using our tool included, hammer this down gently to remove pivot pin.

Cut away remnants of nylon bush with knife as illustrated.

Remove all of bush and clean up hole with sand paper

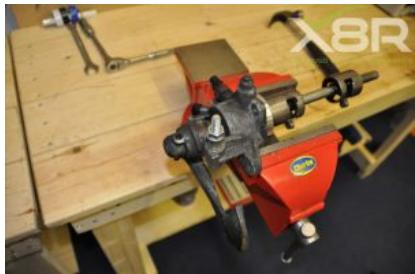
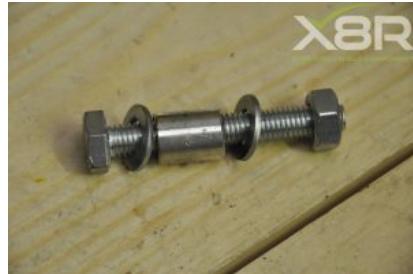
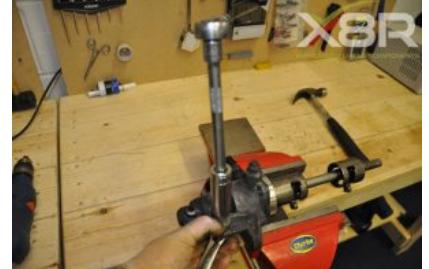
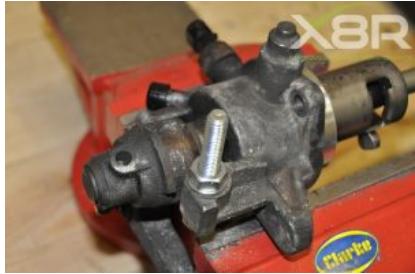
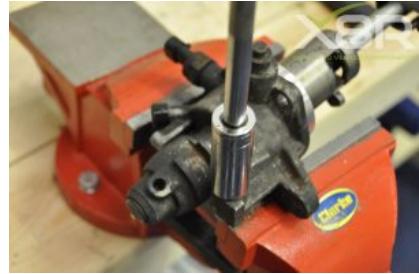
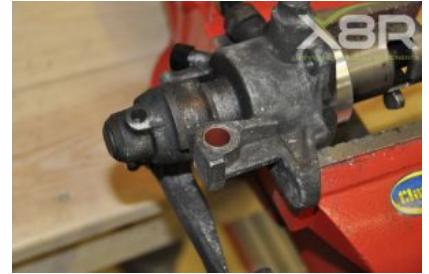
Step 3: Insert new bush

Insert puller bolt with bush in center as illustrated.

Make sure bush is dead central to the hole and draw in slowly in small increments by tightening the puller bolt.

Once fully inserted remove puller bolt and check bush is successfully installed as illustrated.

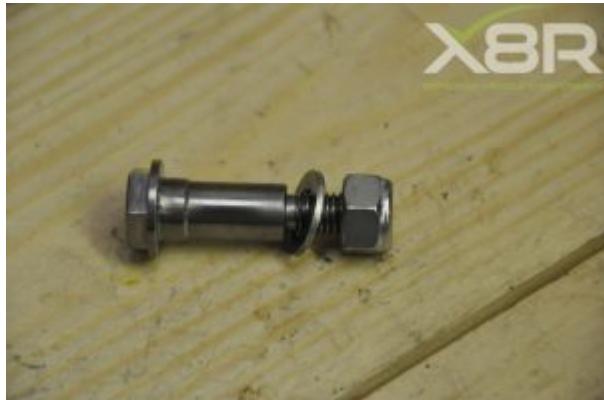
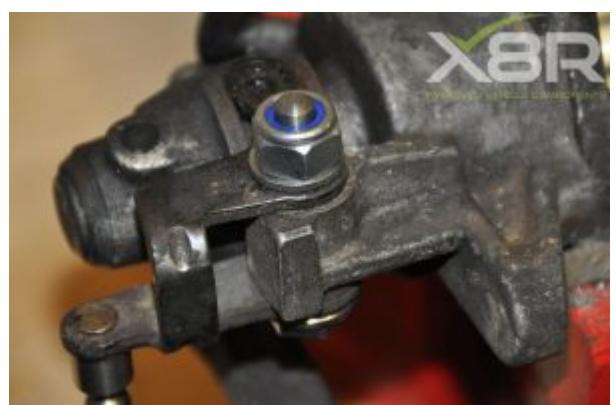
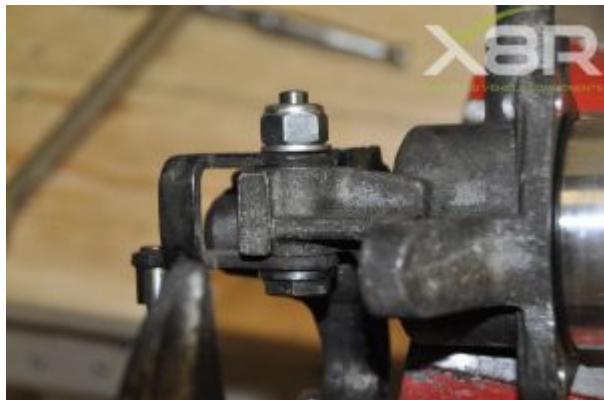
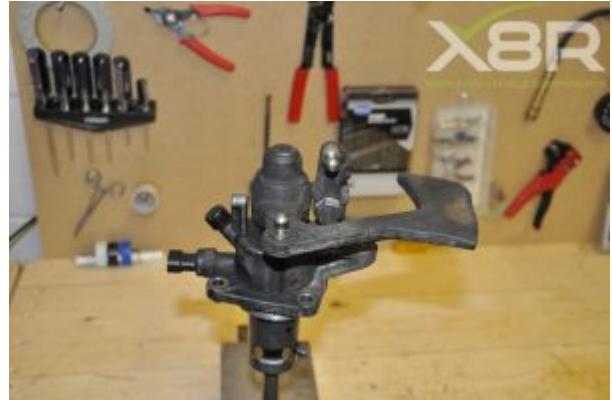
Step 4: Fit new pivot screw

Fit new pivot screw as illustrated.

Test smooth operation of pivot screw.

Refit turret to gearbox.

Test gear selection.
